**Flood Control Project Maintenance
Levee Inspections**

Fall 2015 Levee Maintenance Deficiency Summary Report

City of Sacramento

**Flood Control Project Maintenance
Levee Inspections
Unit Cover Sheet
Fall 2015 Levee Inspection Results
City of Sacramento**

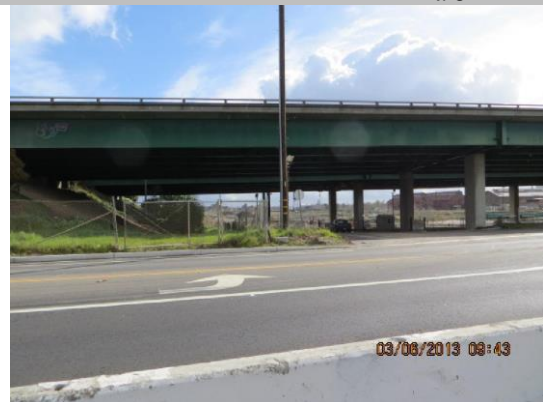
Photo 2 of 3 : UCIP_FA_2015_1743.jpg

Inspector Comments: FS_ID:19967
 DS_ID:21559
 EP_NO: 14527
 FS_HLM: 0.063
 Repair Type: Non-Urgent
 Crossing Status: Found
 UCIP Comments: Need to contact owner to determine condition of crossing and last inspection date.
 FIELD_STRUCT_DESC: 12-inch diameter pipeline under channel through levee, 44 feet below the crown. Southern Pacific Pipe Lines. (Permit No. 14527, Southern Pacific Pipelines, Inc.-1987).
 FS Date: 03/06/2013

View of levee crown at crossing--sign visible on landward side near freeway underpass.

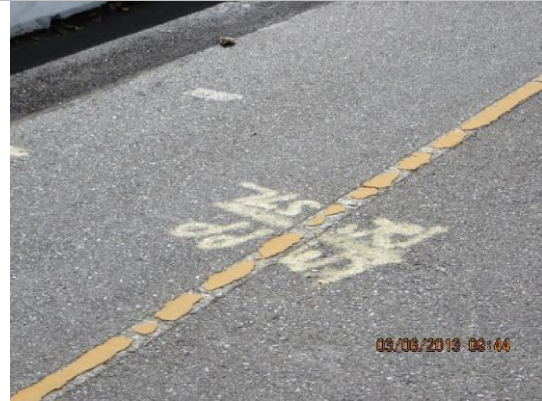
Photo 3 of 3 : UCIP_FA_2015_1744.jpg

LM Start	0.06	Rating **	M	Issue No.	827 (cont)
LM End	0.06	Issue Type +	En	Location *	N/A
Category	Supplemental			GPS Latitude/Longitude	
				Start	End
Item	DWR UCIP Field Study			38.589864 °	38.589864
				-121.505128 °	-121.505128
DWR ID					
Action/Comments					
Inspector Comments: FS_ID:19967					
DS_ID:21559					
EP_NO: 14527					
FS_HLM: 0.063					
Repair Type: Non-Urgent					
Crossing Status: Found

Underground service alert (USA) markings indicate 12 inch crossing through levee.

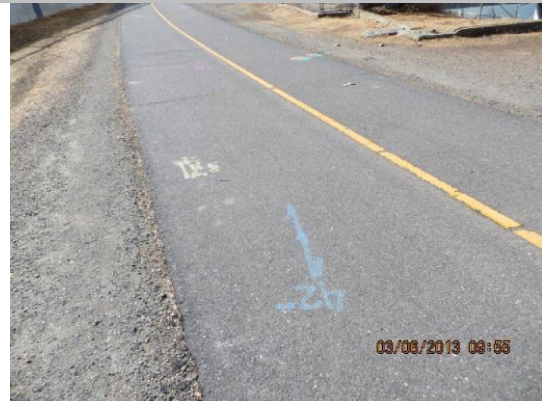
Photo 1 of 3 : UCIP_FA_2015_6329.jpg

LM Start	0.14	Rating **	M	Issue No.	828
LM End	0.14	Issue Type +	En	Location *	N/A
Category	Supplemental			GPS Latitude/Longitude	
				Start	End
Item	DWR UCIP Field Study			38.588768 °	38.588768 °
				-121.504891 °	-121.504891 °
DWR ID					
Action/Comments					
Inspector Comments: FS_ID:41414 DS_ID:24882 EP_NO: N/A FS_HLM: 0.14 Repair Type: Non-Urgent Crossing Status: Indicator Found UCIP Comments: Need to contact owner to determine status of crossing. No permit found during desk study review. FIELD_STRUCT_DESC: 42 inch water transmission main through levee at unknown depth. Crossing installed in 1966. FS Date: 03/06/2013

View of alignment along levee.

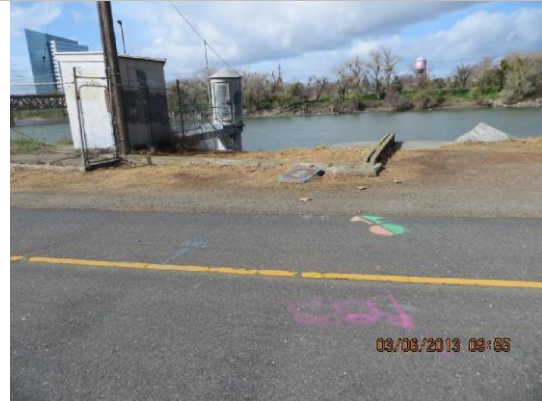
Photo 2 of 3 : UCIP_FA_2015_6330.jpg

LM Start	0.14	Rating **	M	Issue No.	828 (cont)
LM End	0.14	Issue Type +	En	Location *	N/A
Category	Supplemental			GPS Latitude/Longitude	
				Start	End
Item	DWR UCIP Field Study			38.588768 °	38.588768 °
				-121.504891 °	-121.504891 °
DWR ID					
Action/Comments					
Inspector Comments: FS_ID:41414 DS_ID:24882 EP_NO: N/A FS_HLM: 0.14 Repair Type: Non-Urgent Crossing Status: Indicator Found UCIP Comments: Need to contact owner to determine status of crossing. No permit found during desk study review. FIELD_STRUCT_DESC: 42 inch water transmission main through levee at unknown depth. Crossing installed in 1966. FS Date: 03/06/2013

Underground Service Alert (USA) markings indicating 42 inch line through levee.

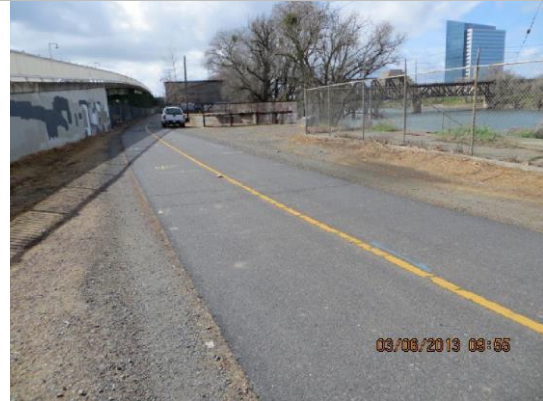
Photo 1 of 2 : UCIP_FA_2015_6332.jpg

LM Start	0.14	Rating **	M	Issue No.	829
LM End	0.14	Issue Type +	En	Location *	N/A
Category	Supplemental			GPS Latitude/Longitude	
				Start	End
Item	DWR UCIP Field Study			38.588738 °	38.588738 °
				-121.504891 °	-121.504891 °
DWR ID					
Action/Comments					
Inspector Comments: FS_ID:41415					
DS_ID:24883					
EP_NO: N/A					
FS_HLM: 0.142					
Repair Type: Non-Urgent					
Crossing Status: Indicator Found

Overview of levee crown looking downstream.

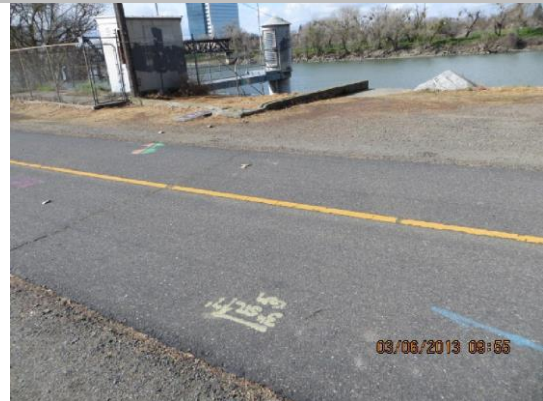
Photo 2 of 2 : UCIP_FA_2015_6339.jpg

Underground Service Alert (USA) markers visible on levee crown.

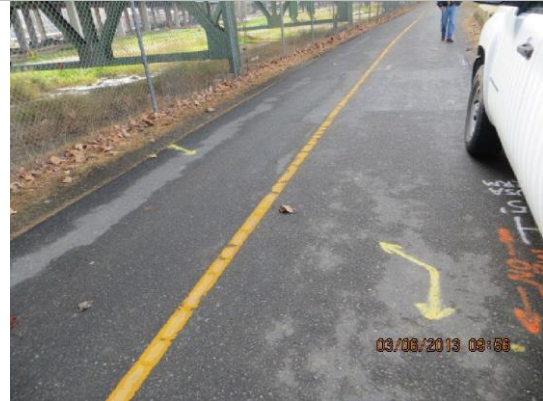
Photo 1 of 3 : UCIP_FA_2015_6334.jpg

LM Start	0.15	Rating **	U	Issue No.	830
LM End	0.15	Issue Type +	En	Location *	N/A
Category	Supplemental			GPS Latitude/Longitude	
				Start	End
Item	DWR UCIP Field Study			38.588636 °	38.588636 °
				-121.504860 °	-121.504860 °
DWR ID					
Action/Comments					
Inspector Comments: FS_ID:40846					
DS_ID:24884					
EP_NO: N/A					
FS_HLM: 0.149					
Repair Type: Urgent					
Crossing Status: Indicator Found

Underground Service Alert (USA) markings of PG&E line through levee,
Photo 2 of 2.

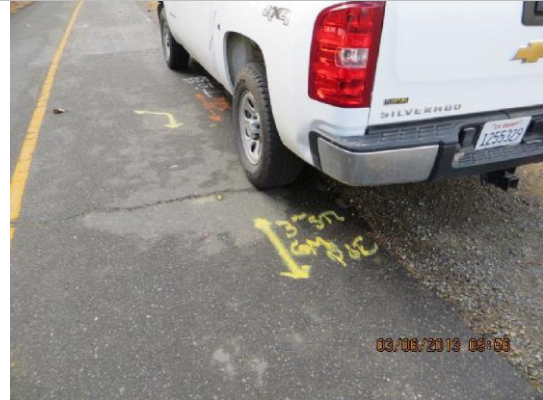
Photo 2 of 3 : UCIP_FA_2015_6335.jpg

Underground Service Alert (USA) markings of PG&E line through levee,
Photo 1 of 2.

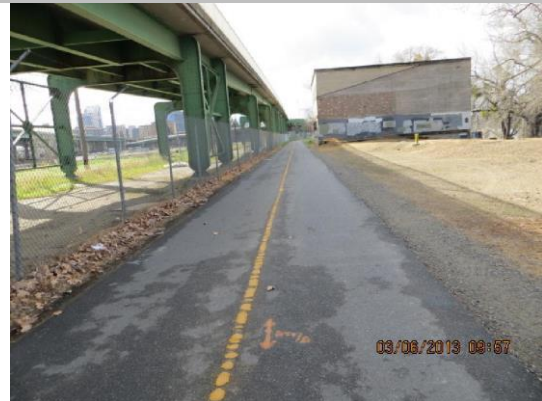
Photo 2 of 2 : UCIP_FA_2015_6338.jpg

LM Start	0.16	Rating **	M	Issue No.	831 (cont)	
LM End	0.16	Issue Type +	En	Location *	N/A	
Category	Supplemental			GPS Latitude/Longitude		
				Start	End	
Item	DWR UCIP Field Study			38.588500 °	38.588500 °	
				-121.504856 °	-121.504856 °	
DWR ID						
Action/Comments						
Inspector Comments: FS_ID:41416						
DS_ID:24885						
EP_NO: N/A						
FS_HLM: 0.158						
Repair Type: Non-Urgent						
Crossing Status: Indicator Found						
UCIP Comments: No markers visible as per Title 23. Recommend having utility owner coordinate with Central Valley Flood Protection Board (CVFPB).						
FIELD_STRUCT_DESC: ATT communication line through levee at unknown depth.						
FS Date: 03/06/2013

Alignment of communication line through levee, Photo 1 of 2.

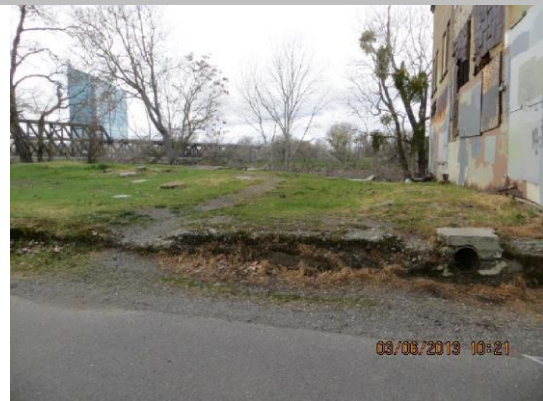
Photo 2 of 3 : UCIP_FA_2015_6340.jpg

Inspector Comments: FS_ID:40848
 DS_ID:24887
 EP_NO: N/A
 FS_HLM: 0.22
 Repair Type: Non-Urgent
 Crossing Status: Indicator Found
 UCIP Comments: Pump station appears non-functional. Owner will need to coordinate with DWR-Inspector and CVFPB to determine if crossing meets Title 23 requirements.
 FIELD_STRUCT_DESC: 12 inch connected to 10 inch pipe through levee at unknown depth.
 FS Date: 03/06/2013

View of levee crown at crossing.

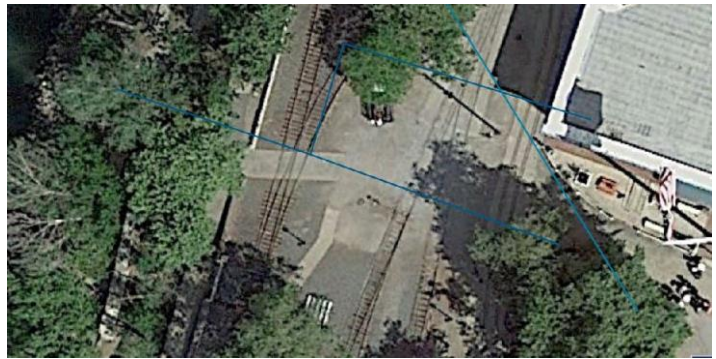
Photo 1 of 1 : UCIP_FA_2015_5926.jpg

LM Start	0.42	Rating **	M	Issue No.	834
LM End	0.42	Issue Type +	En	Location *	N/A
Category	Supplemental			GPS Latitude/Longitude	
				Start	End
Item	DWR UCIP Field Study			38.584794 °	38.584794 °
				-121.505548 °	-121.505548 °
DWR ID					
Action/Comments					
Inspector Comments: FS_ID:41247 DS_ID:24889 EP_NO: N/A FS_HLM: 0.41 Repair Type: Non-Urgent Crossing Status: Indicator Found UCIP Comments: Unable to confirm if crossing exists. Approximate alignment provided by the City of Sacramento. Need to confirm alignment and status of crossing. FIELD_STRUCT_DESC: 10 inch pipe through levee. Record was obtained from Sacramento County approximate utility alignment. FS Date: 03/06/2013

Alignment provided by City of Sacramento of 10 inch line--not found during field inspection.

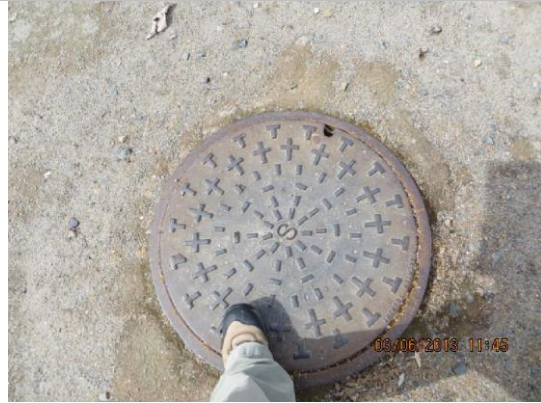
Photo 2 of 3 : UCIP_FA_2015_2045.jpg

View of manhole located at the edge of waterward.

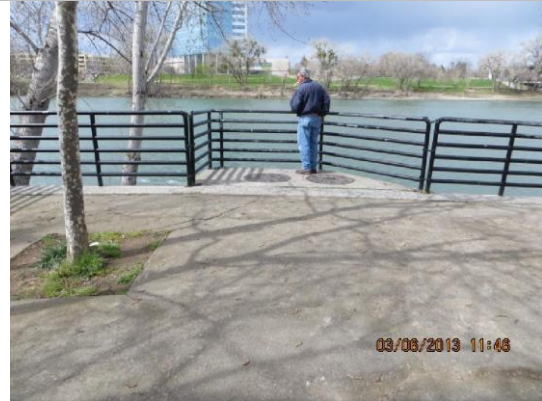
Photo 2 of 3 : UCIP_FA_2015_6343.jpg

Manholes located along levee--waterward side.

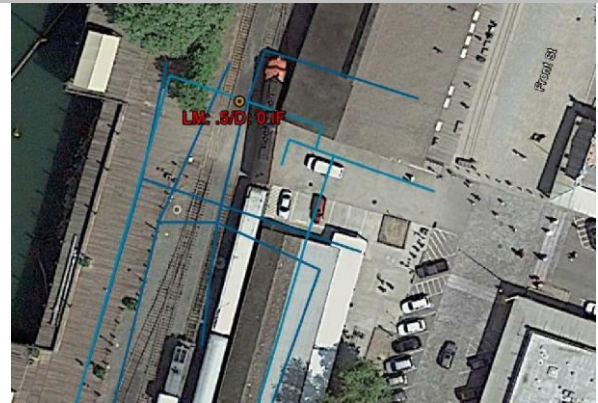
Photo 1 of 1 : UCIP_FA_2015_5927.jpg

LM Start	0.50	Rating **	M	Issue No.	840
LM End	0.50	Issue Type +	En	Location *	N/A
Category	Supplemental			GPS Latitude/Longitude	
				Start	End
Item	DWR UCIP Field Study			38.583693 °	38.583693 °
				-121.505909 °	-121.505909 °
DWR ID					
Action/Comments					
Inspector Comments: FS_ID:41418 DS_ID:24894 EP_NO: N/A FS_HLM: 0.5 Repair Type: Non-Urgent Crossing Status: Indicator Found UCIP Comments: Need to confirm status of crossing and alignment through levee. Unable to find permit during review. FIELD_STRUCT_DESC: 8 inch pipe through levee and along waterward side for about 800 feet. Crosses levee again at 38.581544, -121.506688. FS Date: 03/06/2013

Aproximate alignment provided by City of Sacramento -- unable to confirm if crossing is active.

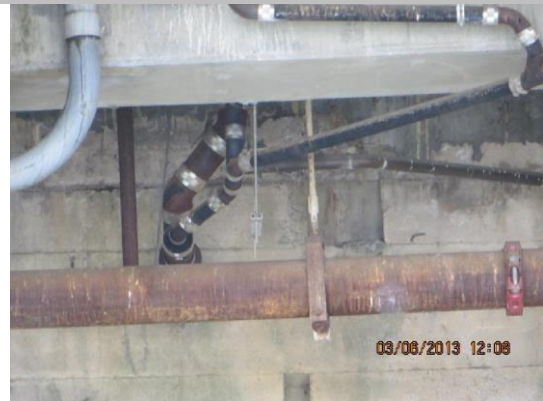
Photo 1 of 1 : UCIP_FA_2015_5929.jpg

LM Start	0.57	Rating **	M	Issue No.	842
LM End	0.57	Issue Type +	En	Location *	N/A
Category	Supplemental			GPS Latitude/Longitude	
				Start	End
Item	DWR UCIP Field Study			38.582689 °	38.582689 °
				-121.506419 °	-121.506419 °
DWR ID					
Action/Comments					
Inspector Comments: FS_ID:41260 DS_ID:24896 EP_NO: N/A FS_HLM: 0.574 Repair Type: Non-Urgent Crossing Status: Indicator Found UCIP Comments: Unable to determine if crossing is active--need to contact owner to determine status and additional details of crossing. FIELD_STRUCT_DESC: Conduit group through floodwall. FS Date: 03/06/2013

Conduit through floodwall.

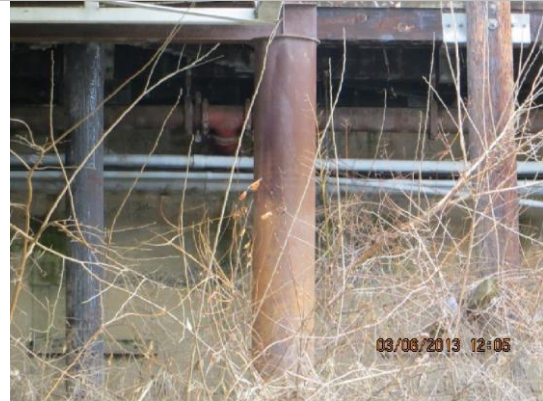
Photo 1 of 1 : UCIP_FA_2015_5930.jpg

LM Start	0.58	Rating **	M	Issue No.	843
LM End	0.58	Issue Type +	En	Location *	N/A
Category	Supplemental			GPS Latitude/Longitude	
				Start	End
Item	DWR UCIP Field Study			38.582482 °	38.582482 °
				-121.506346 °	-121.506346 °
DWR ID					
Action/Comments					
Inspector Comments: FS_ID:41263					
DS_ID:24897					
EP_NO: N/A					
FS_HLM: 0.585					
Repair Type: Non-Urgent					
Crossing Status: Indicator Found					
UCIP Comments: Need to contact owner. Need to determine permit issued for crossing.					
FIELD_STRUCT_DESC: 8 -10 inch pipe through levee.					
FS Date: 03/06/2013

Pipe through floodwall.

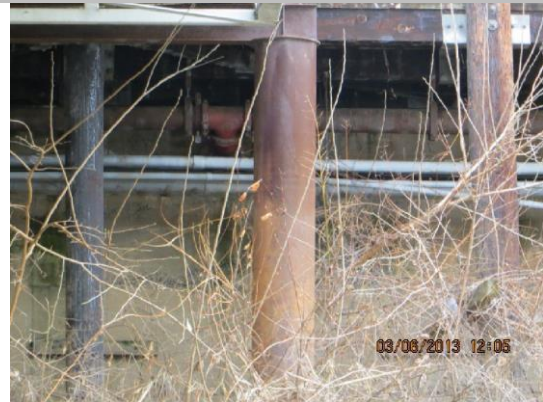
Photo 1 of 1 : UCIP_FA_2015_5931.jpg

LM Start	0.61	Rating **	M	Issue No.	844
LM End	0.61	Issue Type +	En	Location *	N/A
Category	Supplemental			GPS Latitude/Longitude	
				Start	End
Item	DWR UCIP Field Study			38.582167 °	38.582167 °
				-121.506537 °	-121.506537 °
DWR ID					
Action/Comments					
Inspector Comments: FS_ID:41438					
DS_ID:24898					
EP_NO: N/A					
FS_HLM: 0.61					
Repair Type: Non-Urgent					
Crossing Status: Indicator Found					
UCIP Comments: Unable to determine if crossing is active--need to contact owner to determine status and additional details of crossing.					
FIELD_STRUCT_DESC: Sewer line through levee.					
FS Date: 03/06/2013

View of crossing visible from waterward side looking at floodwall.

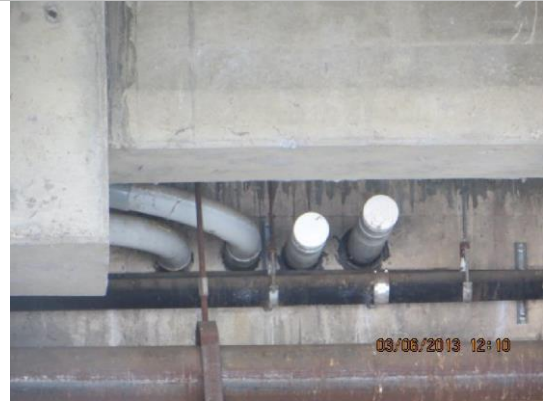
Photo 1 of 1 : UCIP_FA_2015_5932.jpg

View of conduits through floodwall visible from waterward side.

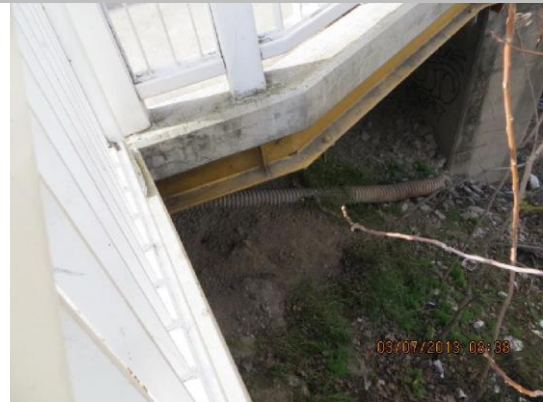
Photo 2 of 3 : UCIP_FA_2015_5935.jpg

Pipe visible on waterward side.

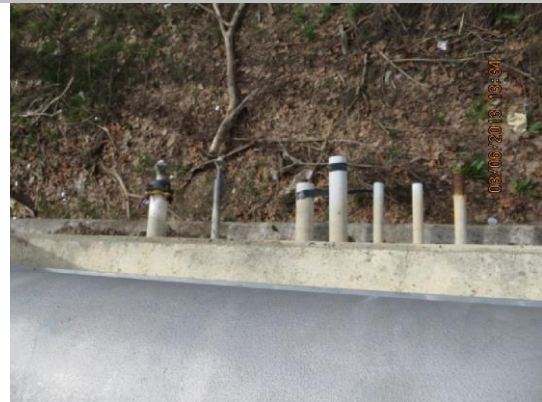
Photo 2 of 3 : UCIP_FA_2015_5947.jpg

Conduits through floodwayll.

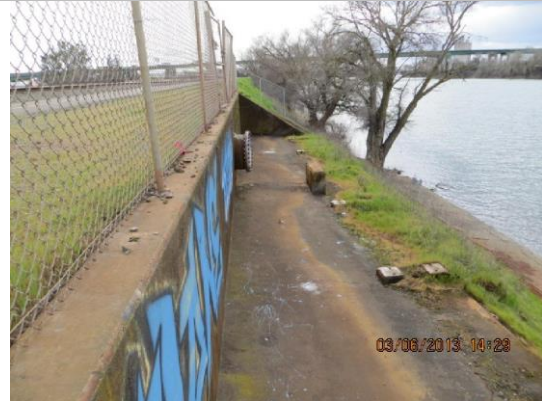
Photo 2 of 3 : UCIP_FA_2015_1811.jpg

Headwall with 1 crossing capped off.

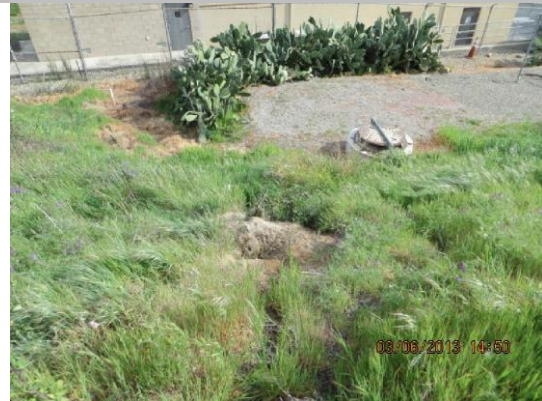
Photo 2 of 2 : UCIP_FA_2015_1806.jpg

View of landward side--tall grass along slope limit inspection.

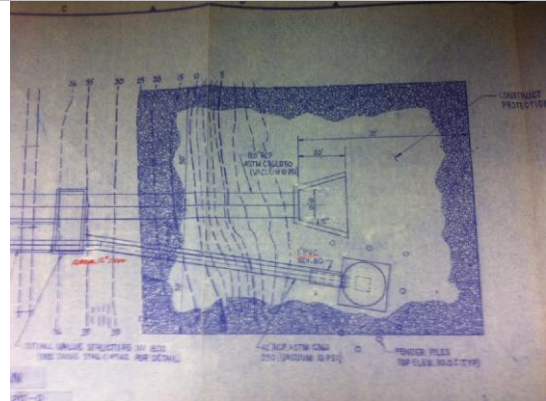
Photo 3 of 3 : UCIP_FA_2015_2027.jpg

Rip rap protection around outfall structure for 42-inch and 120-inch pipes.

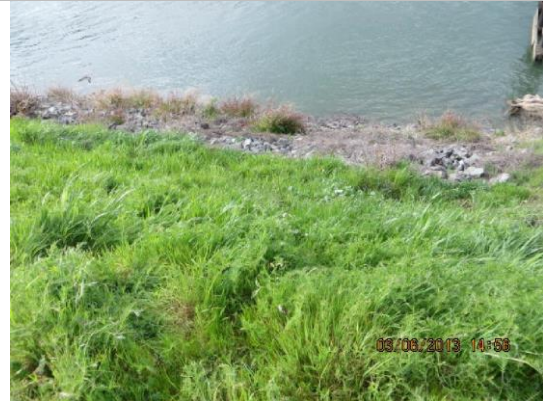
Photo 1 of 3 : UCIP_FA_2015_2034.jpg

Tall grass along pipe alignment--limited inspection.

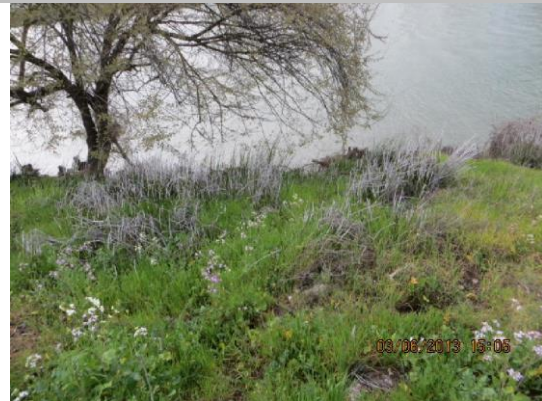
Photo 2 of 3 : UCIP_FA_2015_1242.jpg

View of waterward slope--tall grass limits inspection.

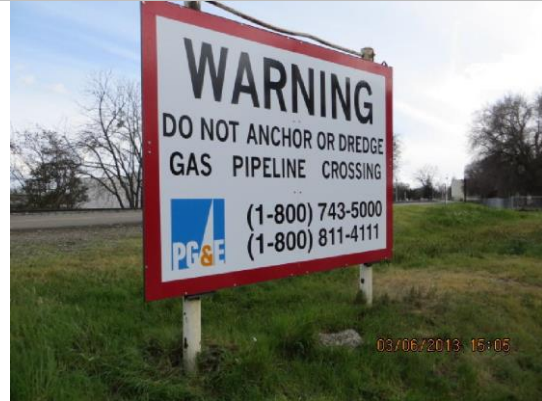
Photo 3 of 3 : UCIP_FA_2015_1243.jpg

PG&E warning gas line crossing--waterward side view.

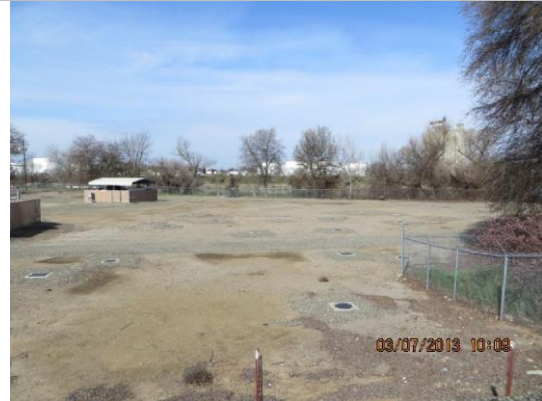
Photo 1 of 3 : UCIP_FA_2015_4266.jpg

More vapor wells present on levee crown.

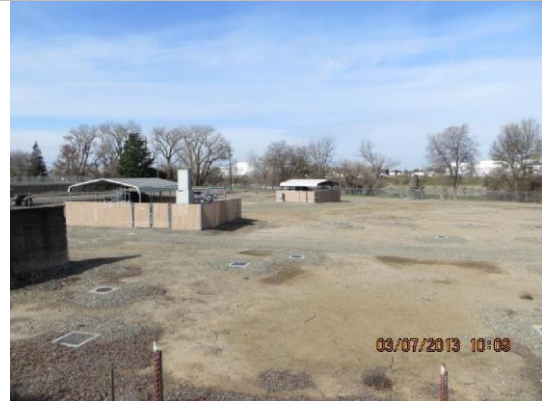
Photo 2 of 3 : UCIP_FA_2015_4267.jpg

Several vapor wells present inside fenced area.

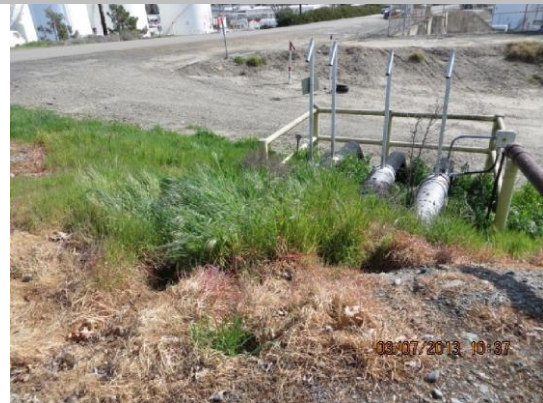
Photo 2 of 3 : UCIP_FA_2015_4154.jpg

Dense burrow activity along landward slope.

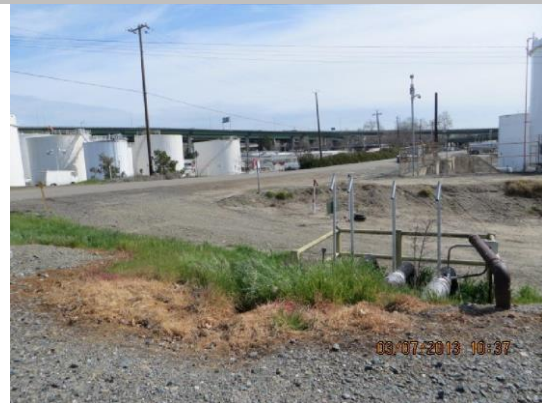
Photo 1 of 3 : UCIP_FA_2015_4145.jpg

Overview of 4-10 inch lines through levee--landward side.

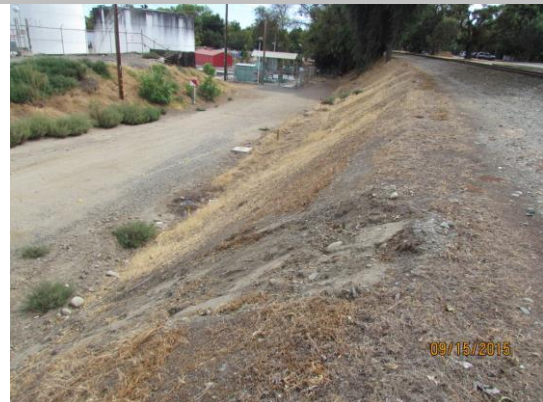
Photo 1 of 2 : FA_2015_NA0005_251_76_20150921_00029.jpg

View of the slope stability on the landward side of the levee looking downstream. Fall 2015.

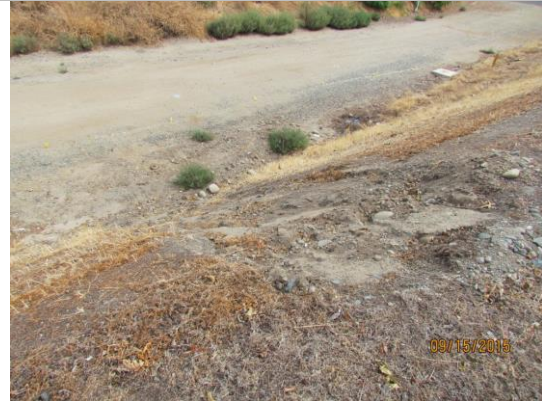
Photo 2 of 2 : FA_2015_NA0005_251_76_20150921_00030.jpg

A close-up view of the slope stability. Fall 2015.

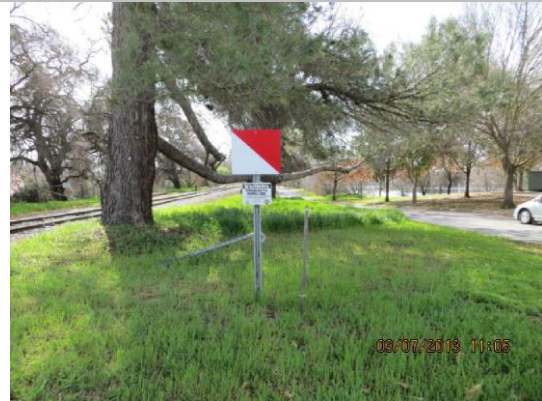
Photo 1 of 1 : UCIP_FA_2015_5952.jpg

Marker of gas line visible on levee crown next to railroad tracks.

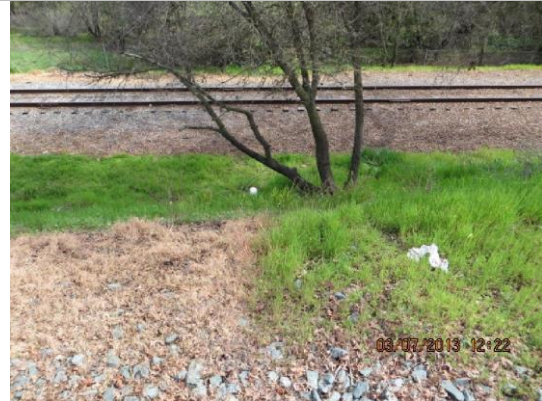
Photo 2 of 2 : UCIP_FA_2015_5954.jpg

PVC pipe through levee.

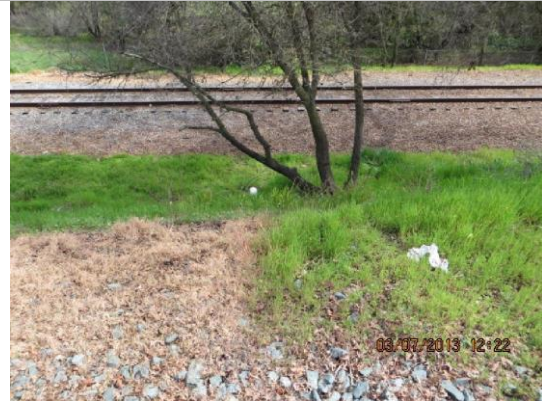
Photo 2 of 2 : UCIP_FA_2015_5956.jpg

PVC pipe through levee.

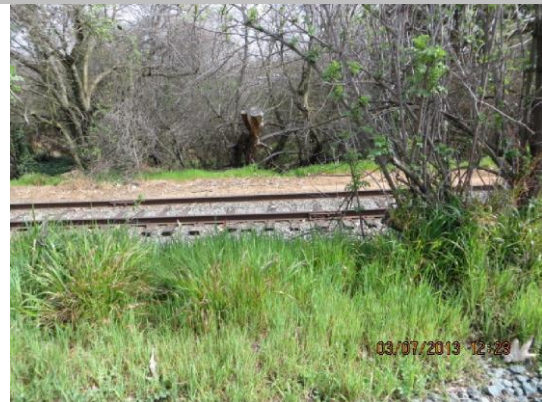
Photo 1 of 2 : UCIP_FA_2015_5957.jpg

Dense vegetation along landward slope.

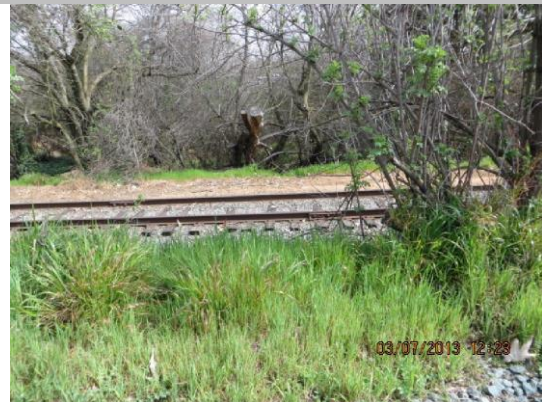
Photo 1 of 2 : UCIP_FA_2015_5959.jpg

Dense vegetation on landward side.

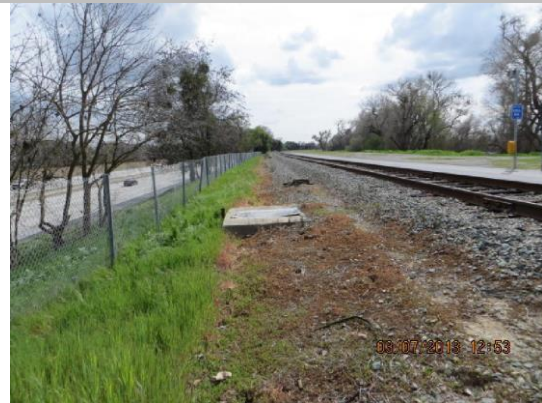
Photo 3 of 3 : UCIP_FA_2015_4161.jpg

Concrete vault located on landward shoulder.
